# **BADEN POWELL TRAIL RESTORATION PROJECT REPORT— AUGUST 2020**

FUNDED BY GMR FOUNDATION, B.C. MOUNTAIN  
FOUNDATION AND B.C. MOUNTAINEERING CLUB

IN PARTNERSHIP WITH WEST VANCOUVER PARKS

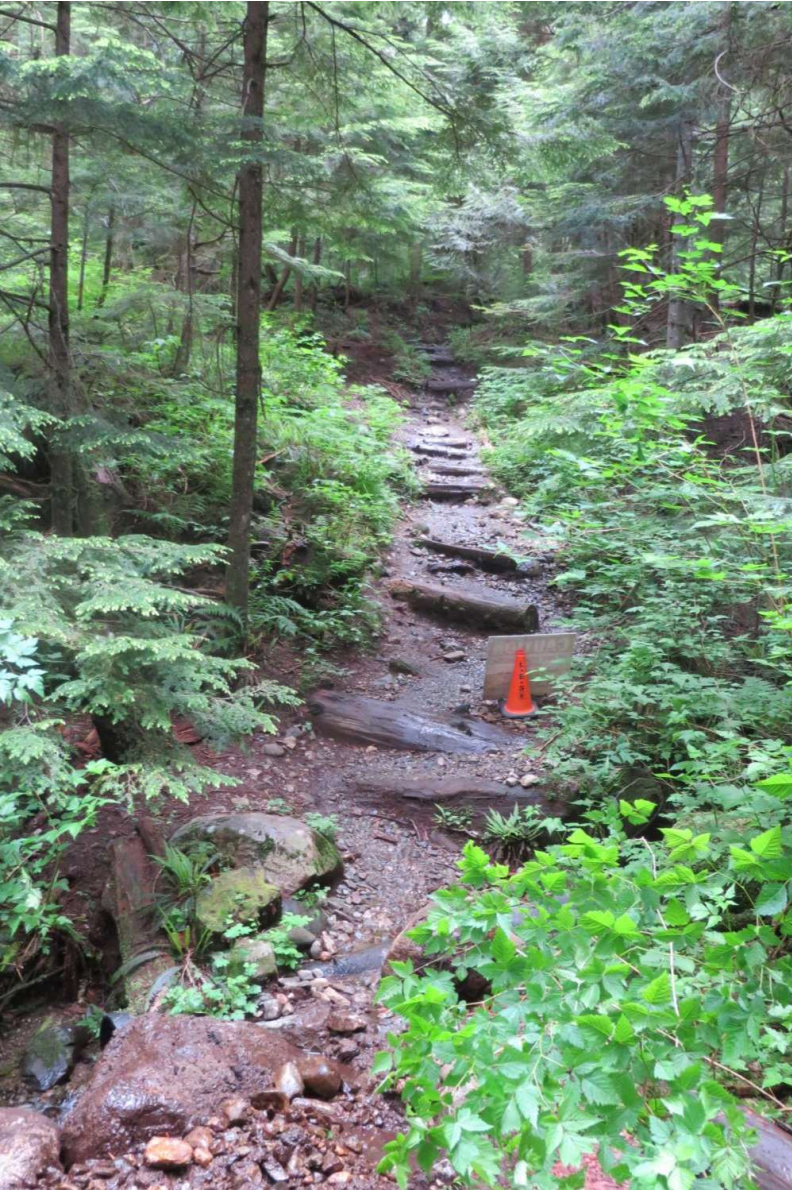
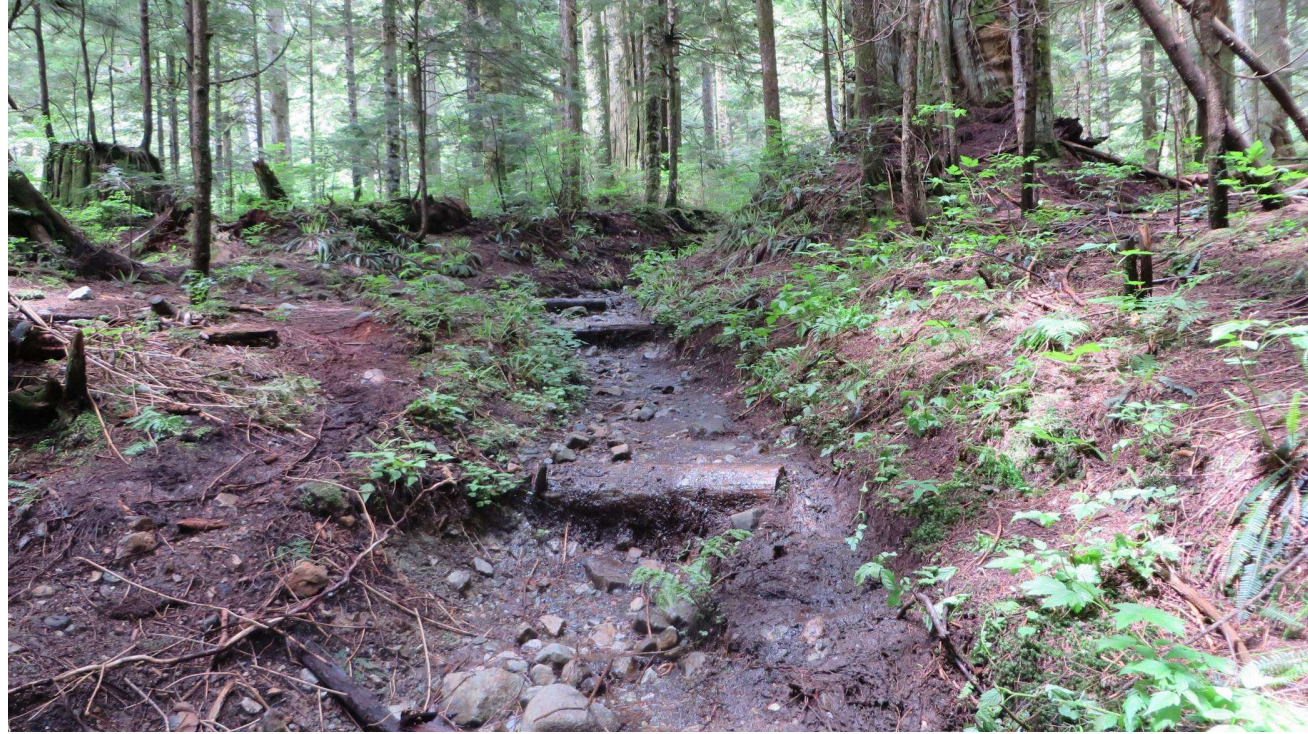
**BEFORE: TRAIL BRAIDING AROUND STEPS, CONSTANT EROSION FROM SEEPAGE AND WATER FLOWING DOWN TRAIL**

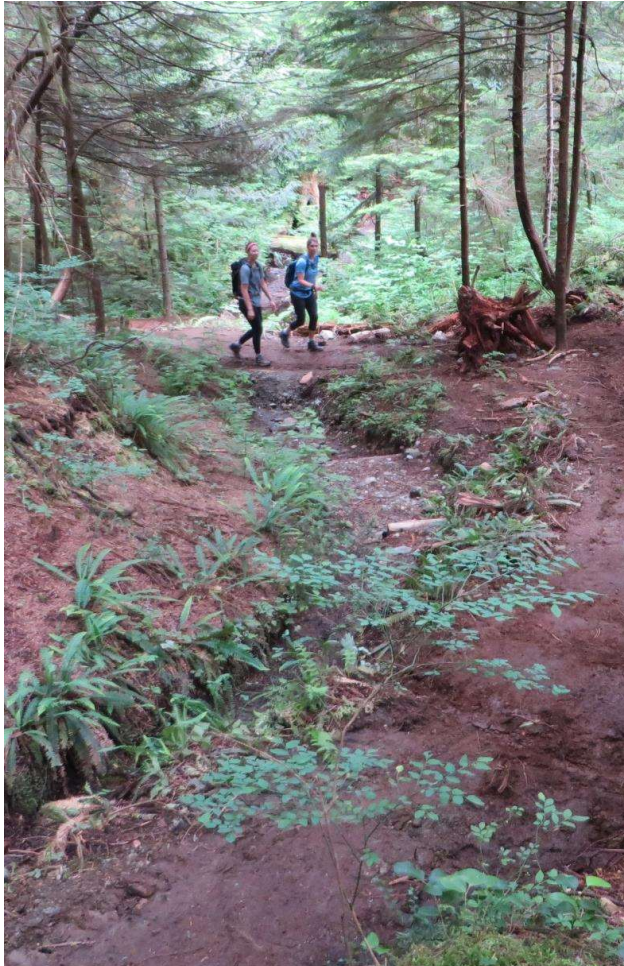
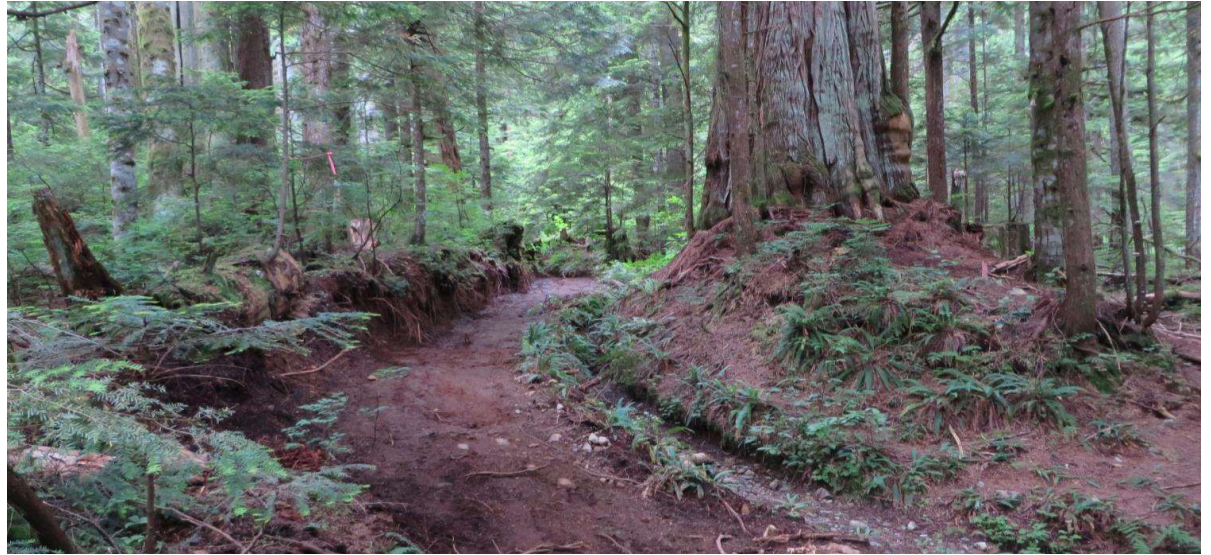
**AFTER: SHORT SWITCHBACKS REPLACE STEPS,  
DRAINAGE DITCH CHANNELS WATER FLOW**

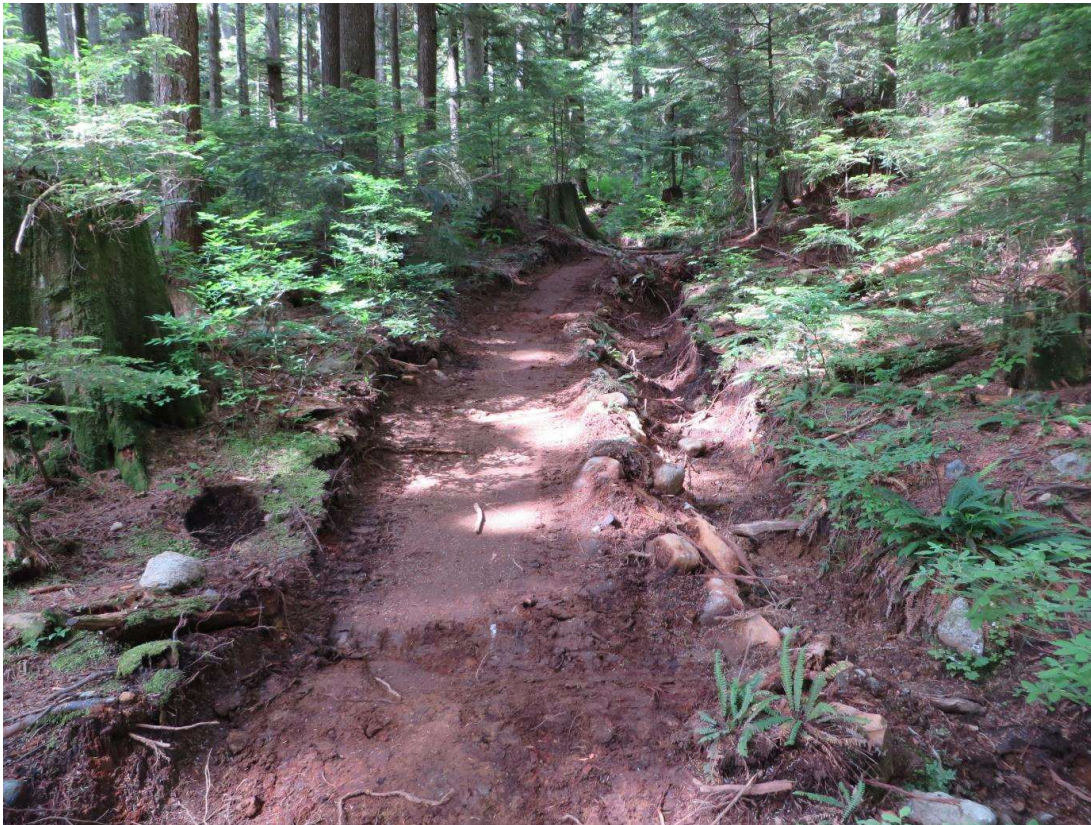
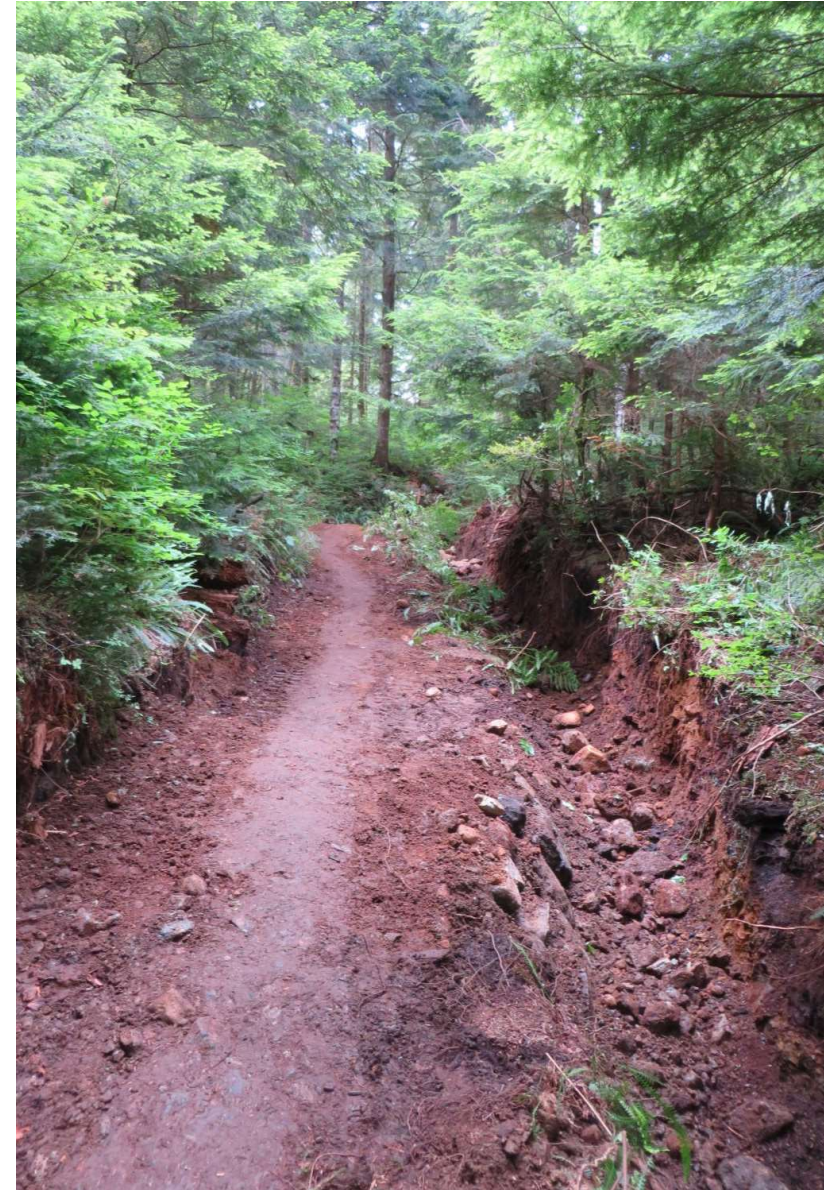
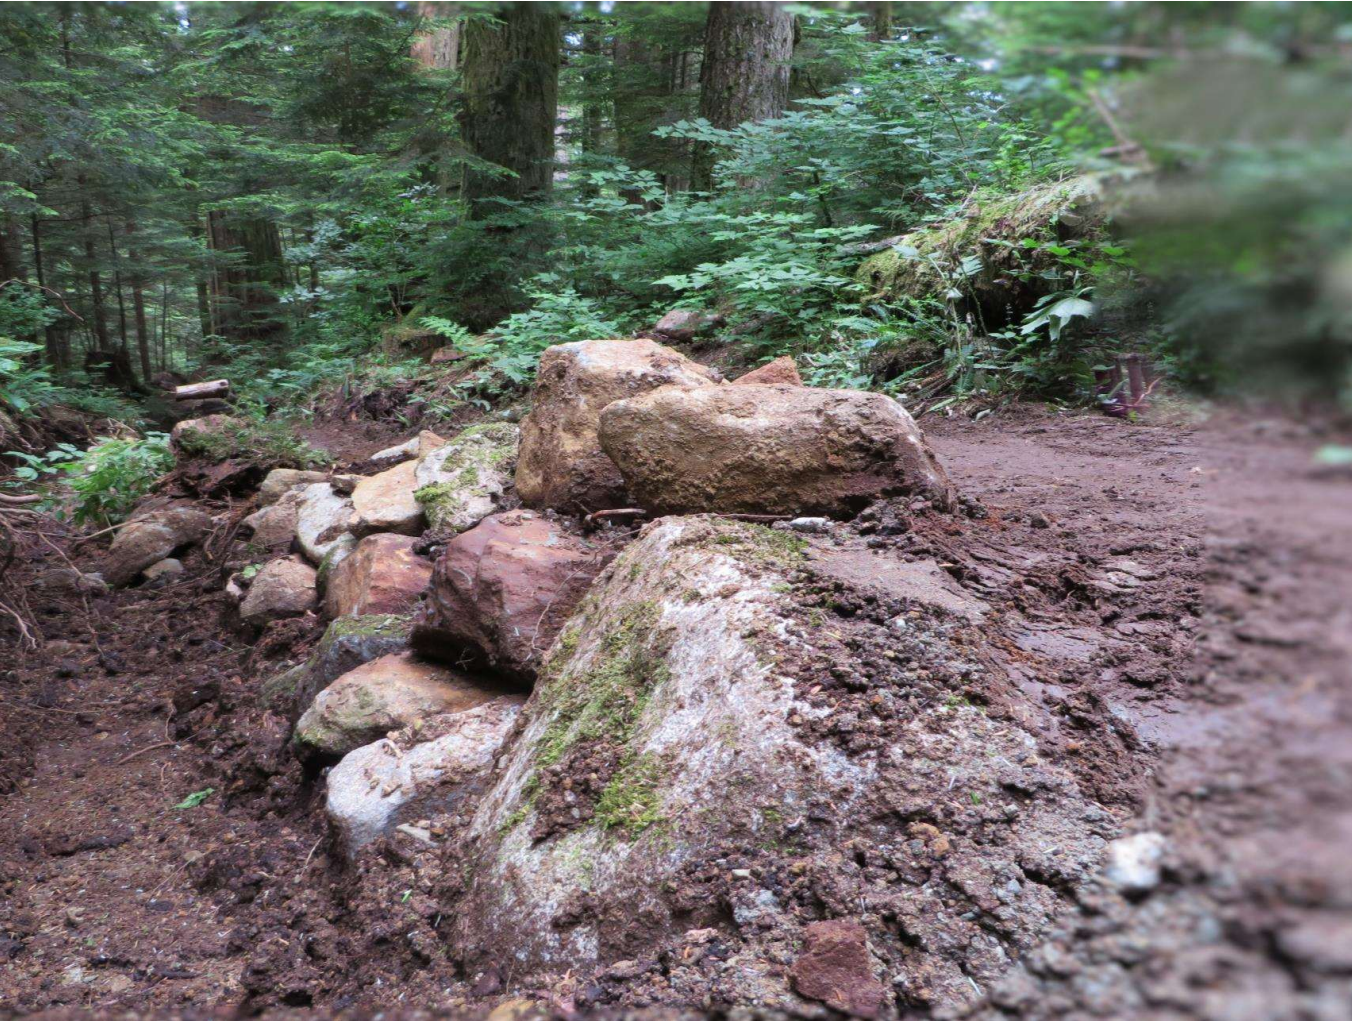
## TRAIL TREAD RESTORED

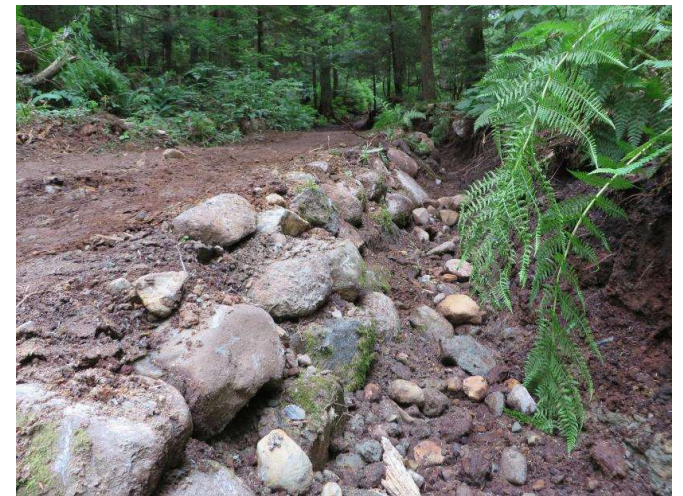
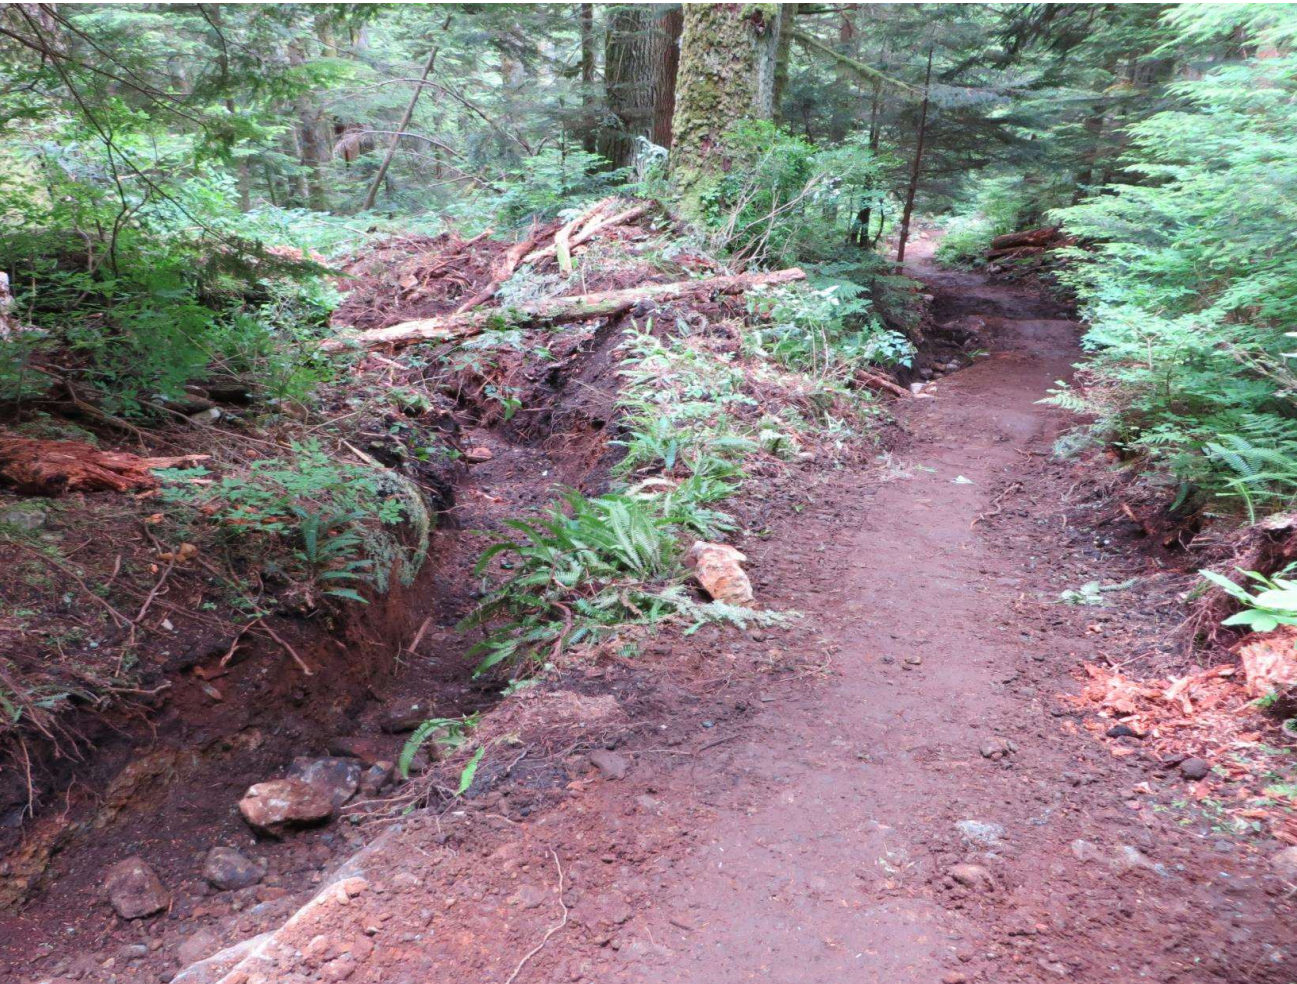
**STACKED BOULDERS  
LINE DITCH EDGES**

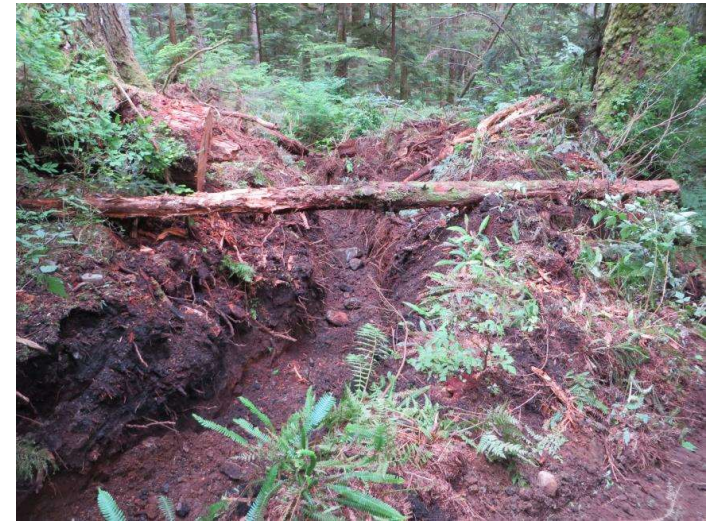
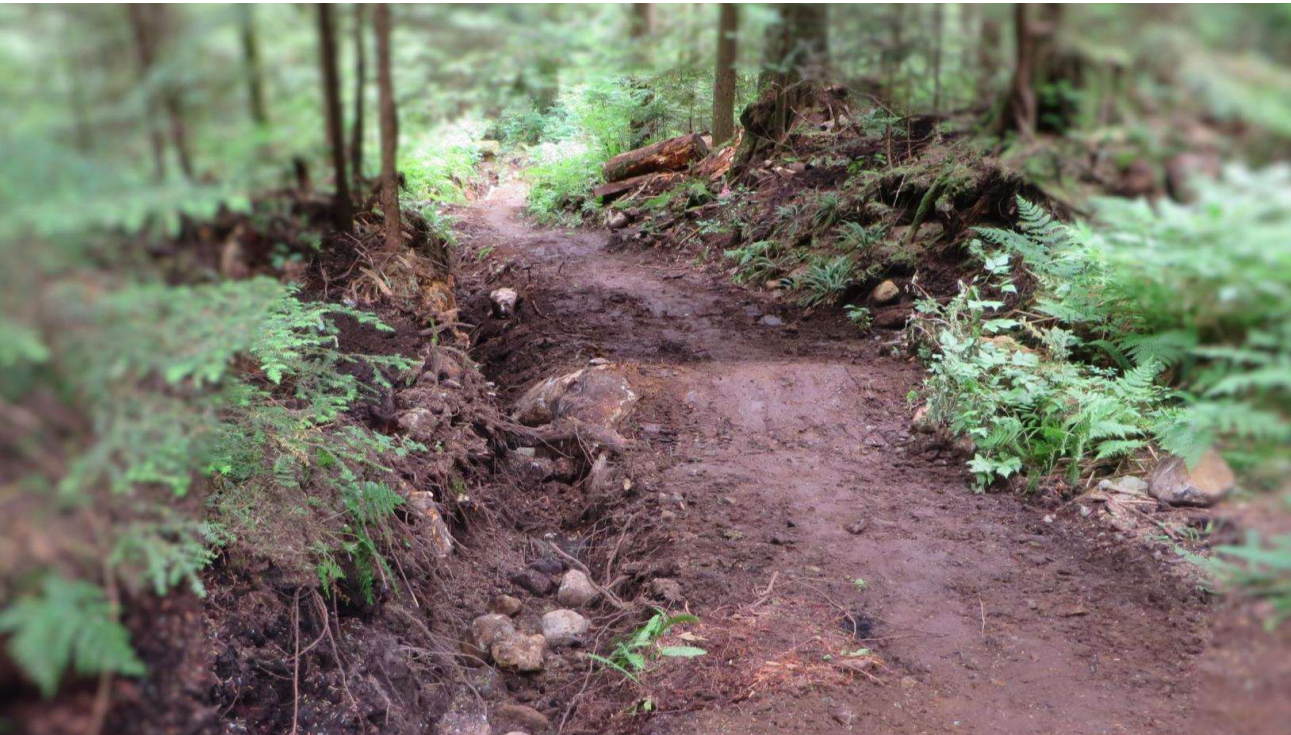
## **NEW DRAINAGE CHANNEL FOR HEAVY RUNOFF**

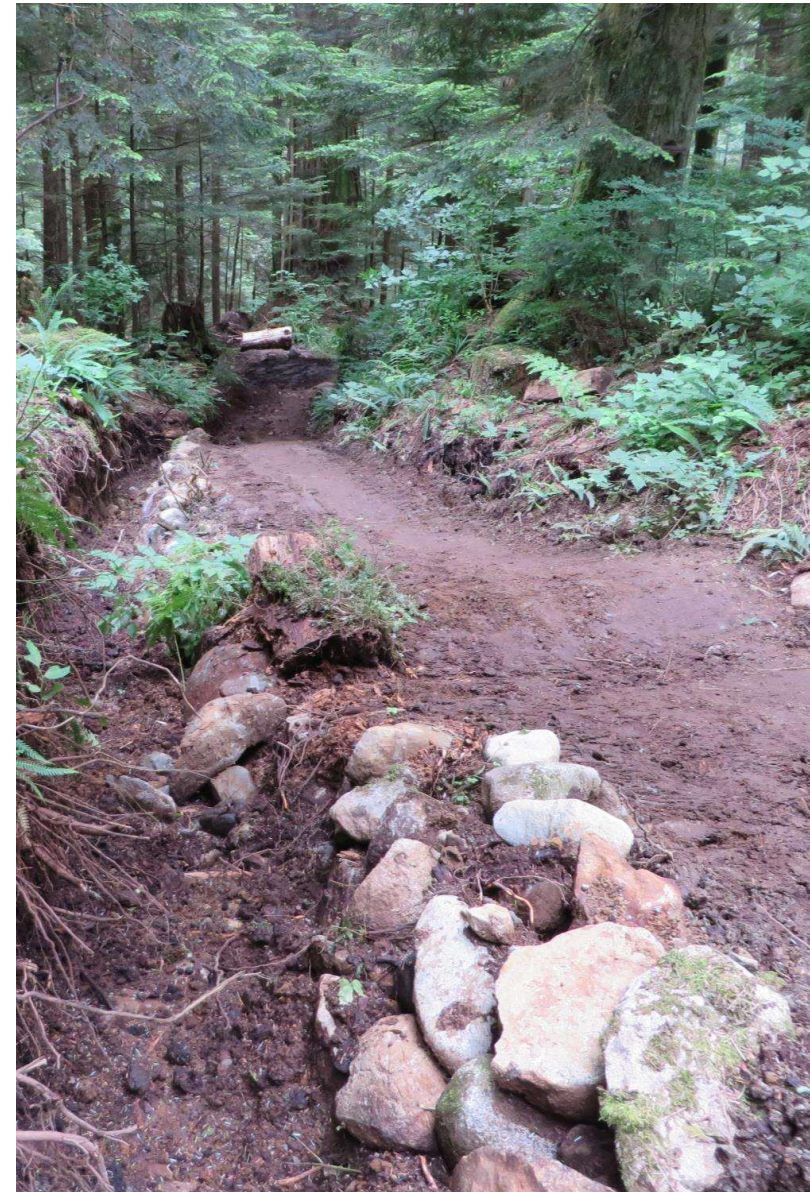
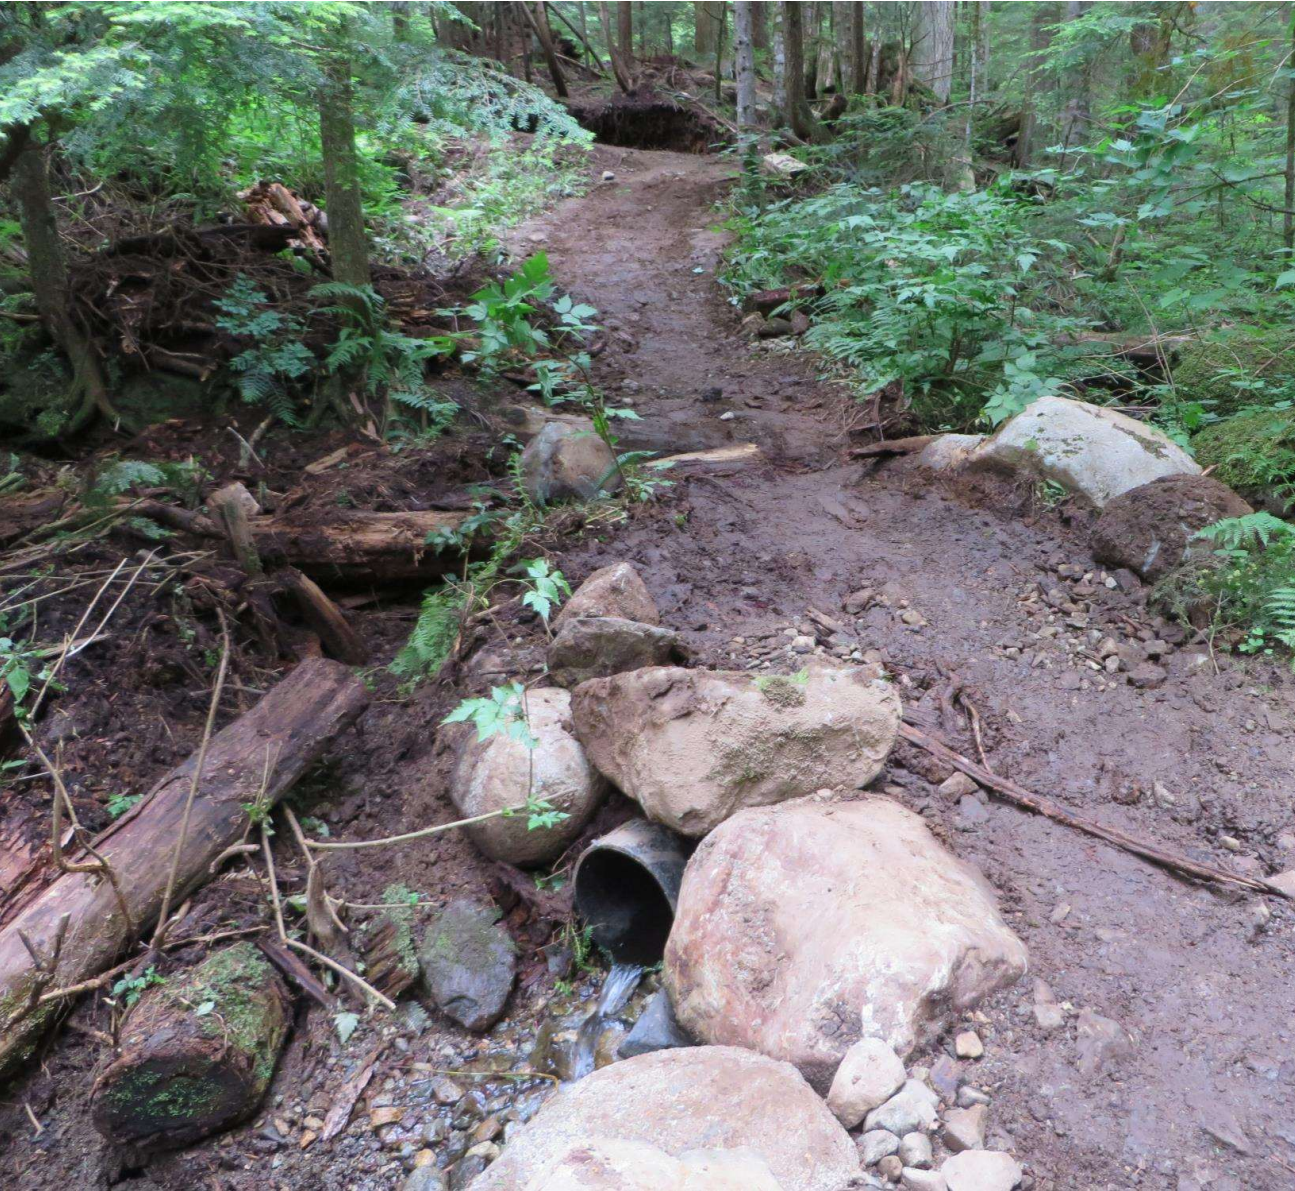
## **GENTLE SWALES ON THE TRAIL TREAD CHANNEL RUNOFF INTO DITCH**

Swales are intentionally constructed depressions in the trail surface that allow for the drainage of water across the trail surface.

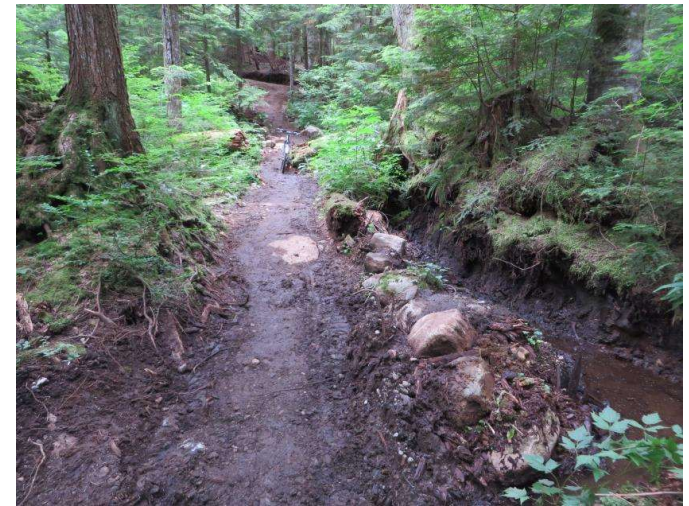
**CULVERT COVERED AND  
DIVERSION CHANNEL EXCAVATED  
TO HANDLE OVERFLOW DURING  
HIGH STREAM FLOW**
